Test Report

No. SHAMLP2103157108

The following sample(s) was/were submitted and identified on behalf of the clients as : THERMAL TRANSFER RIBBON

SGS Job No. : SHIN2102011208PC - SH
 Product Specification : Wax/RESIN (UR218)
 Manufacturer : POMA
 BRAND:POMA
 Date of Sample Received : 26 Feb 2021
 Testing Period : 26 Feb 2021 - 04 Mar 2021
 Test Requested : Selected test(s) as requested by client.
 Test Method : Please refer to next page(s).
 Test Results : Please refer to next page(s).

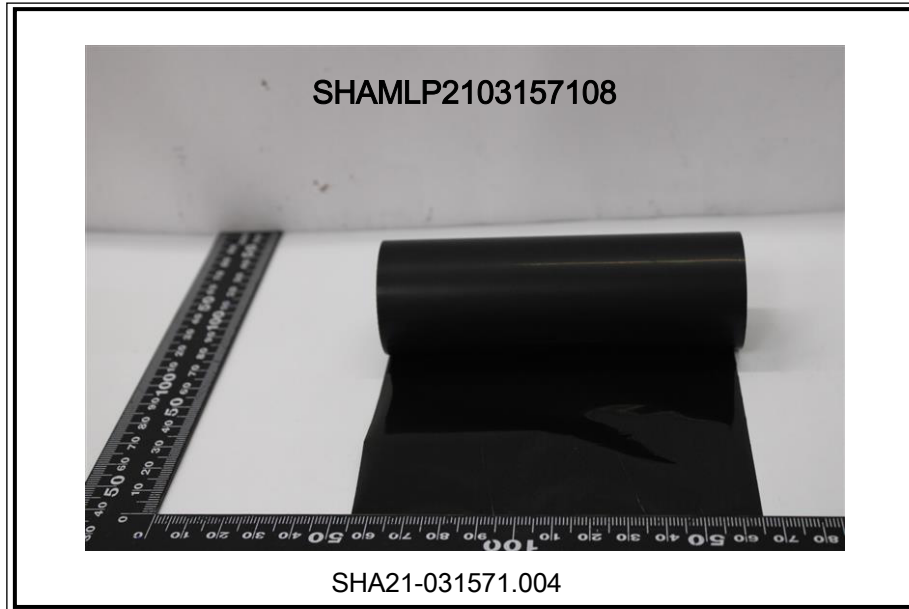
Sample photo:

Specimen No.	SGS Sample ID	Description
SN1	SHA21-031571.004	Black film
